Situation Photo Log

Tuesday, October 23, 2012

Kalamazoo River / Enbridge Spill

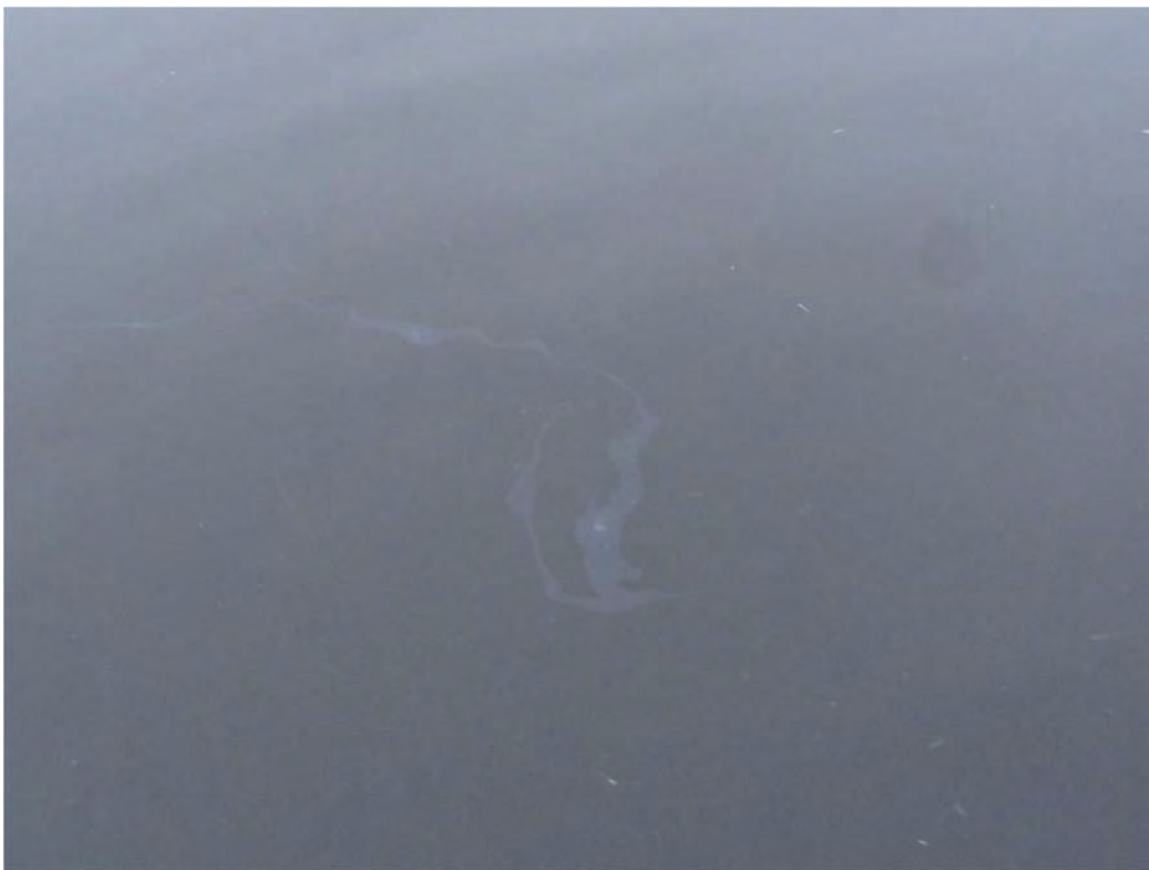
1. MP5.15 LDB area where sheen and tar globs were observed.

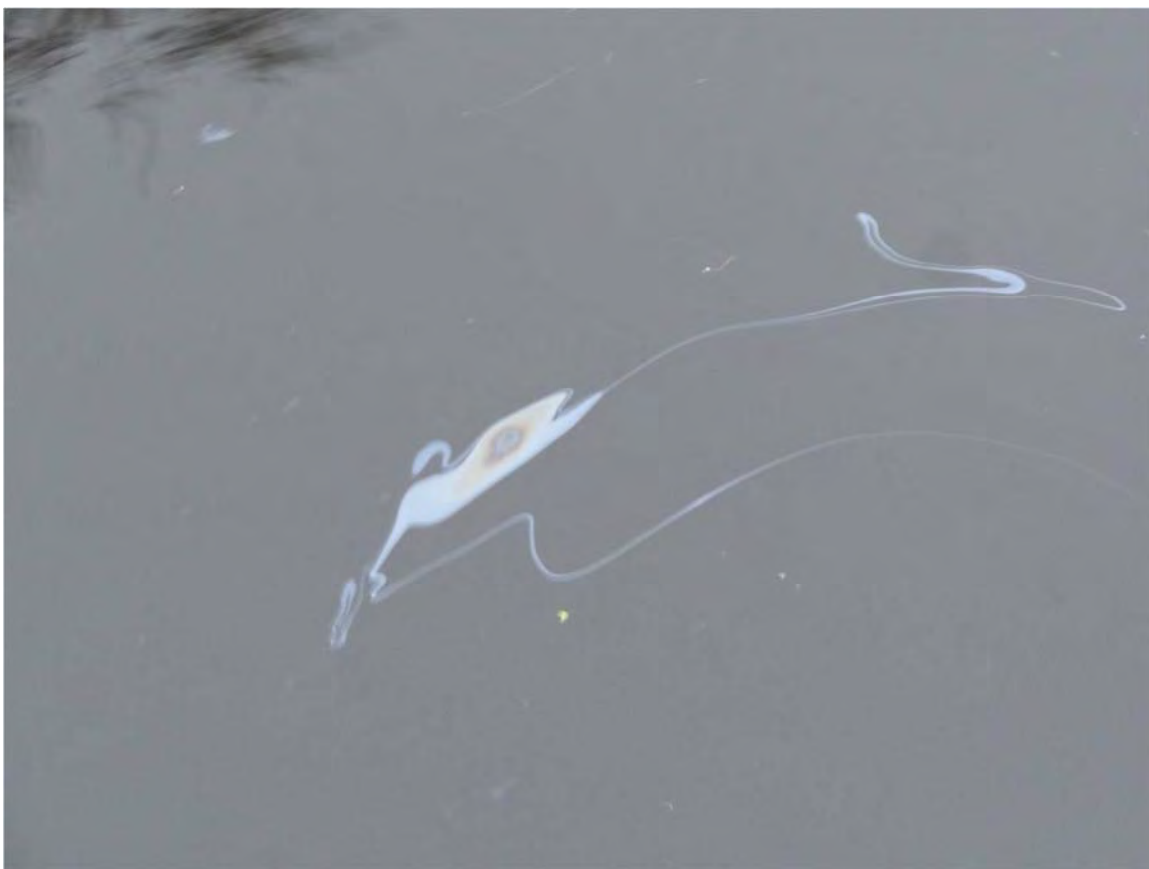
2. MP5.25 LDB sheen and tar globs were observed.

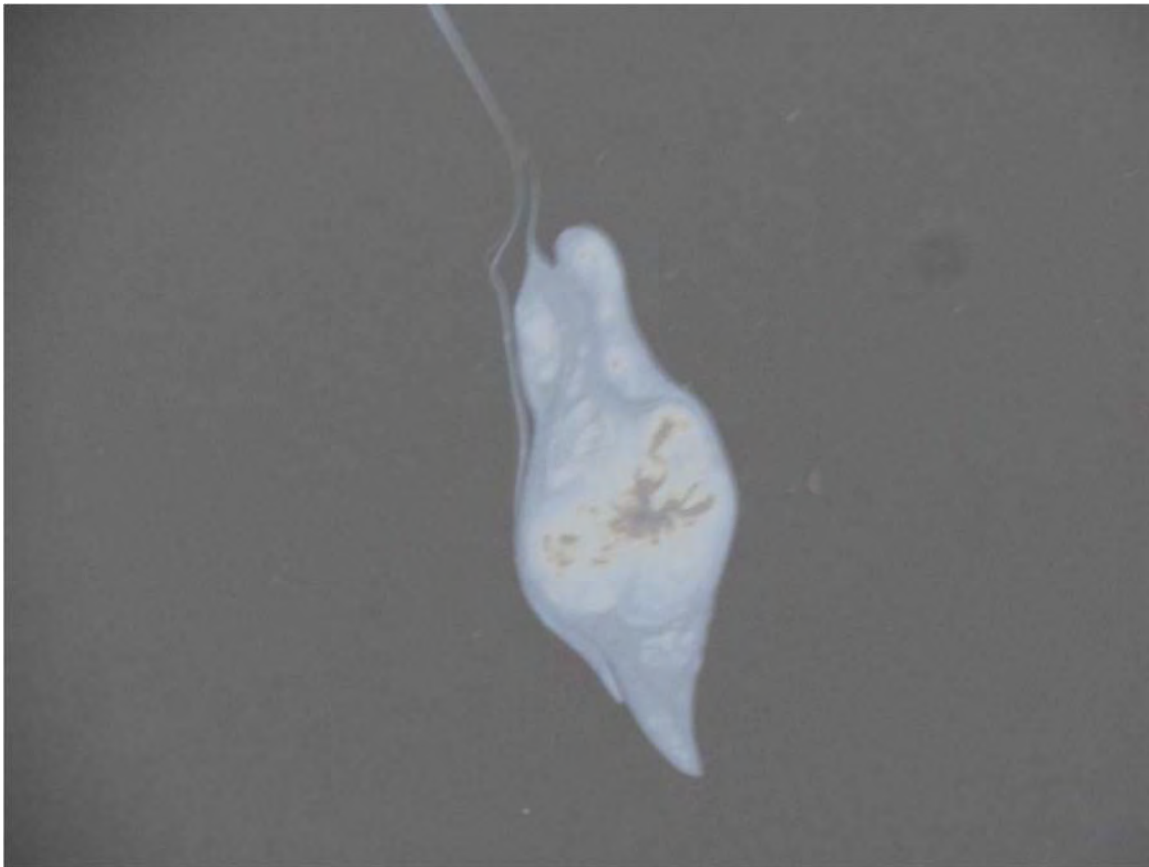
3. MP5.35 LDB sheen and tar globs observed.

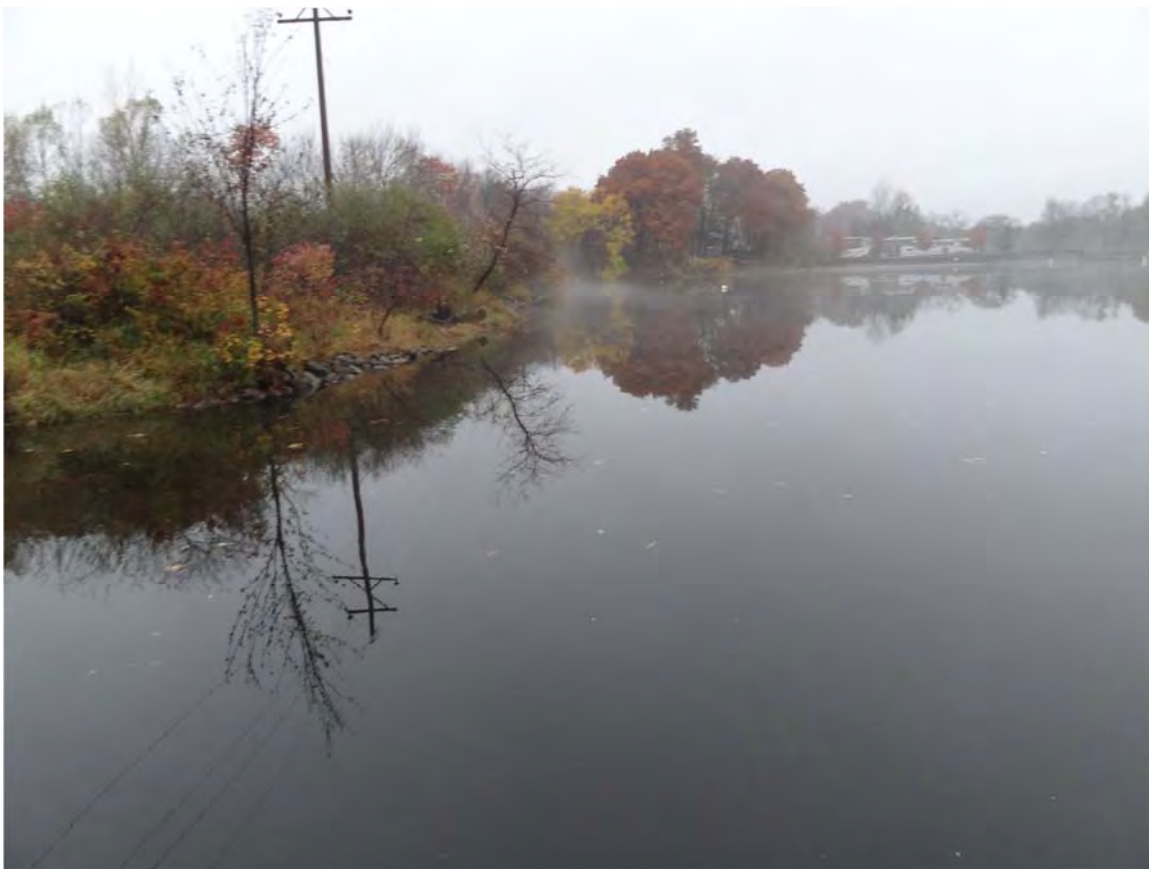
4. MP5.63 LDB area where sheen and tar globs were observed.

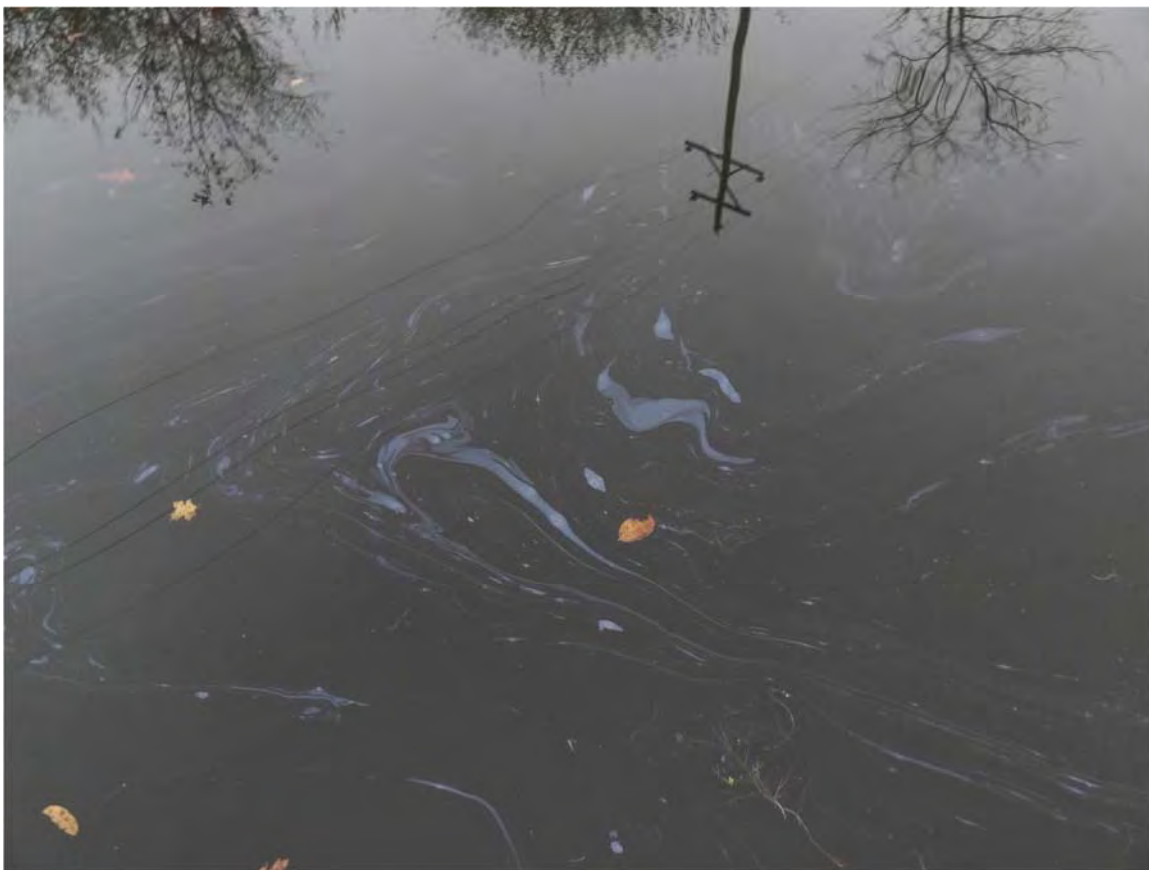
5. MP5.63 LDB sheen and tar globs observed.

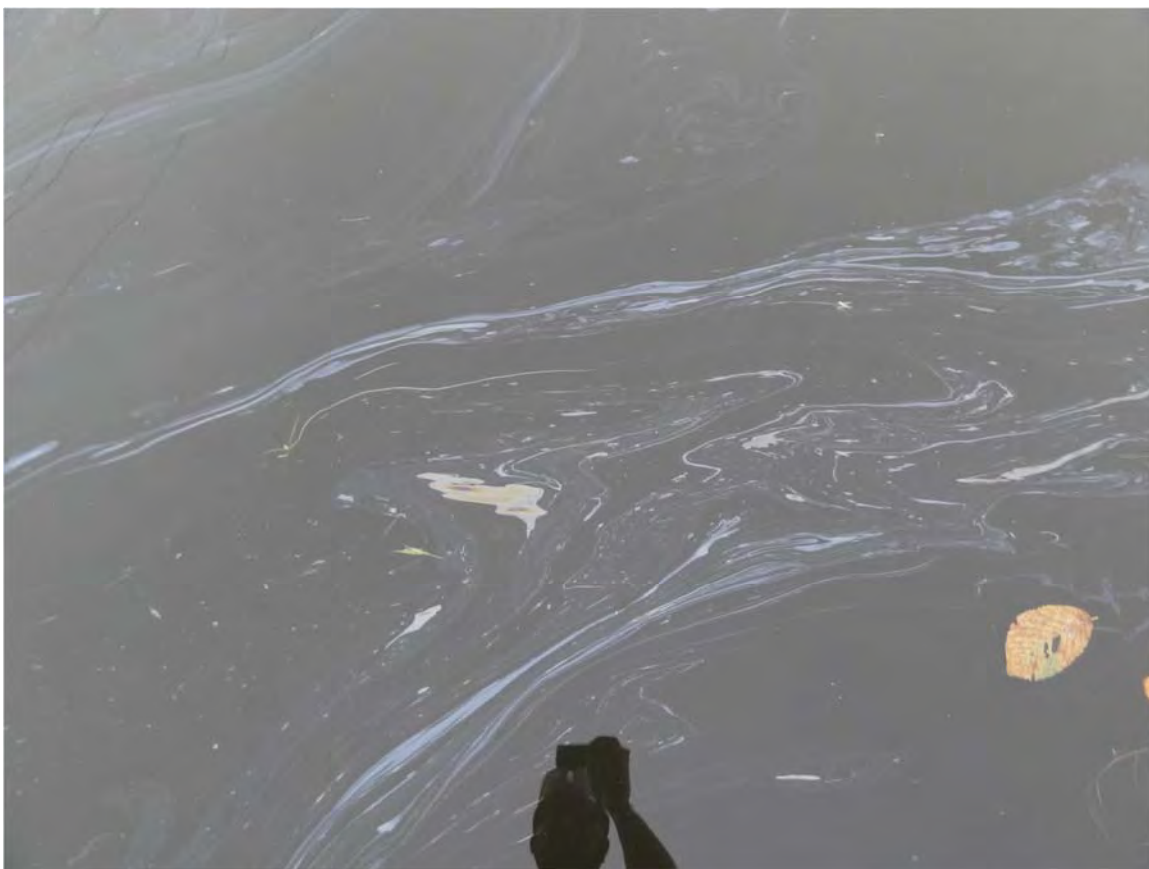
6. MP5.63 LDB sheen and tar globs observed.

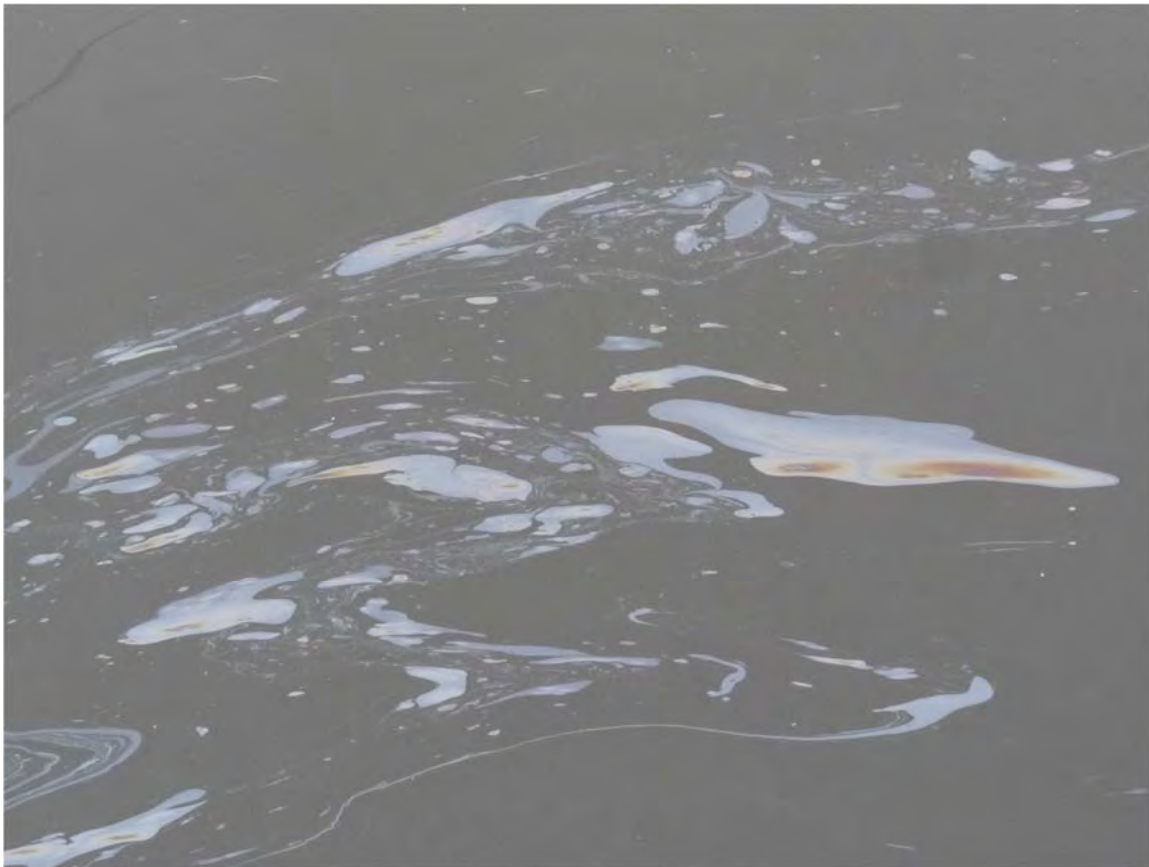
7. MP5.63 LDB sheen and tar globs observed.

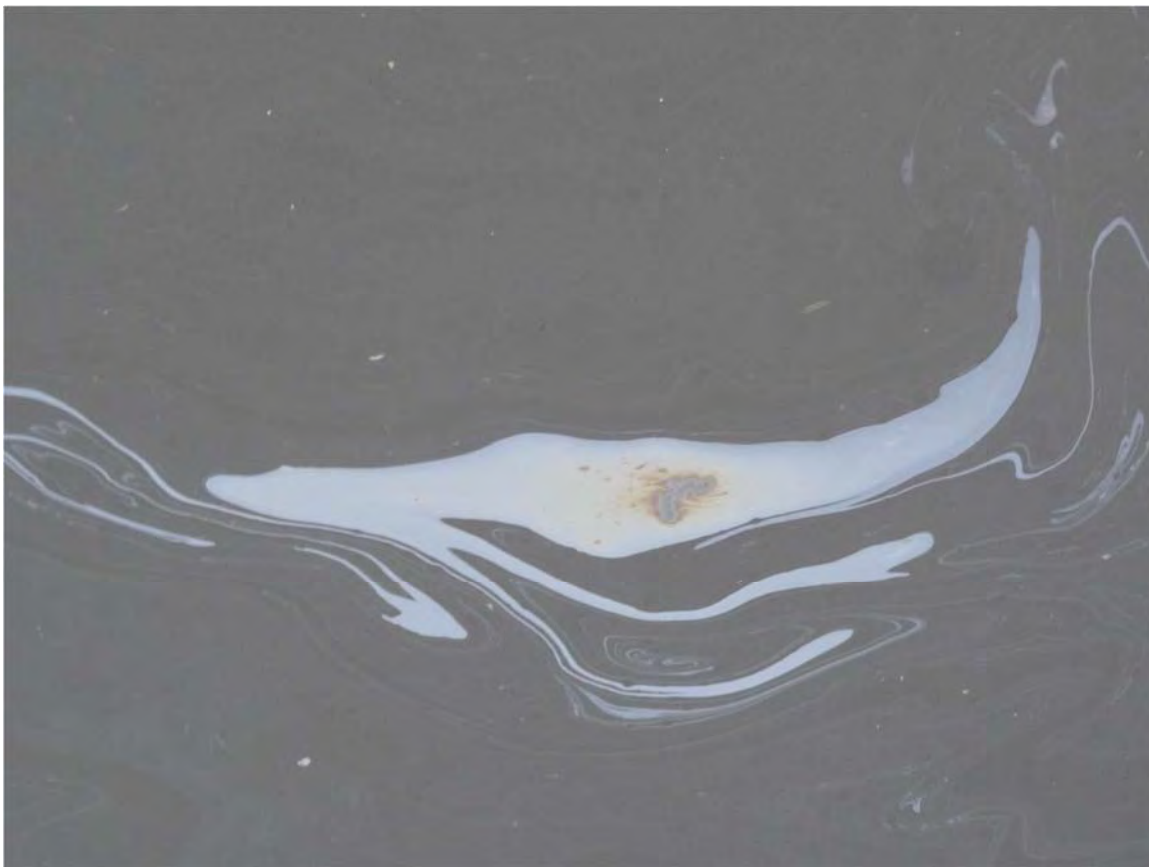
8. MP5.63 LDB sheen and tar globs were observed.

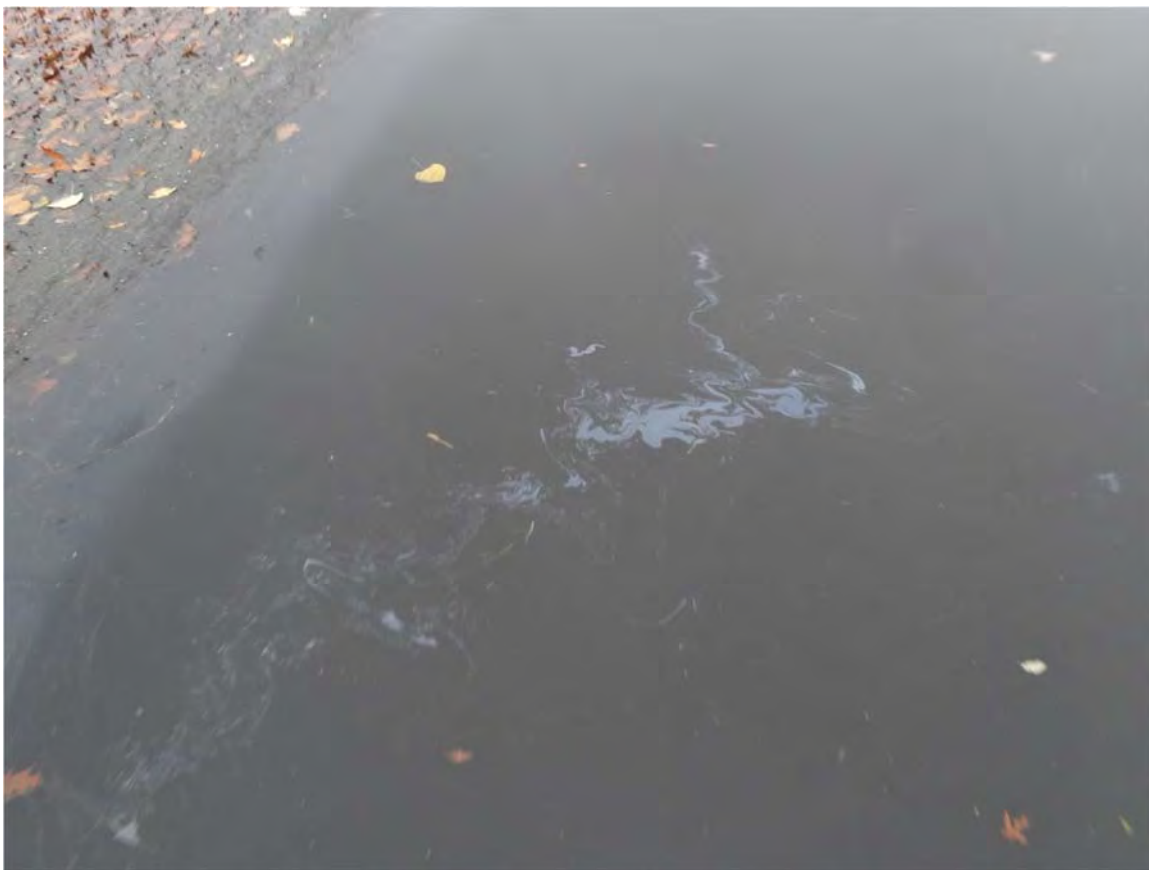
9. Ceresco Dam Control Point Boom observed sheen and tar globs collecting along the boom.

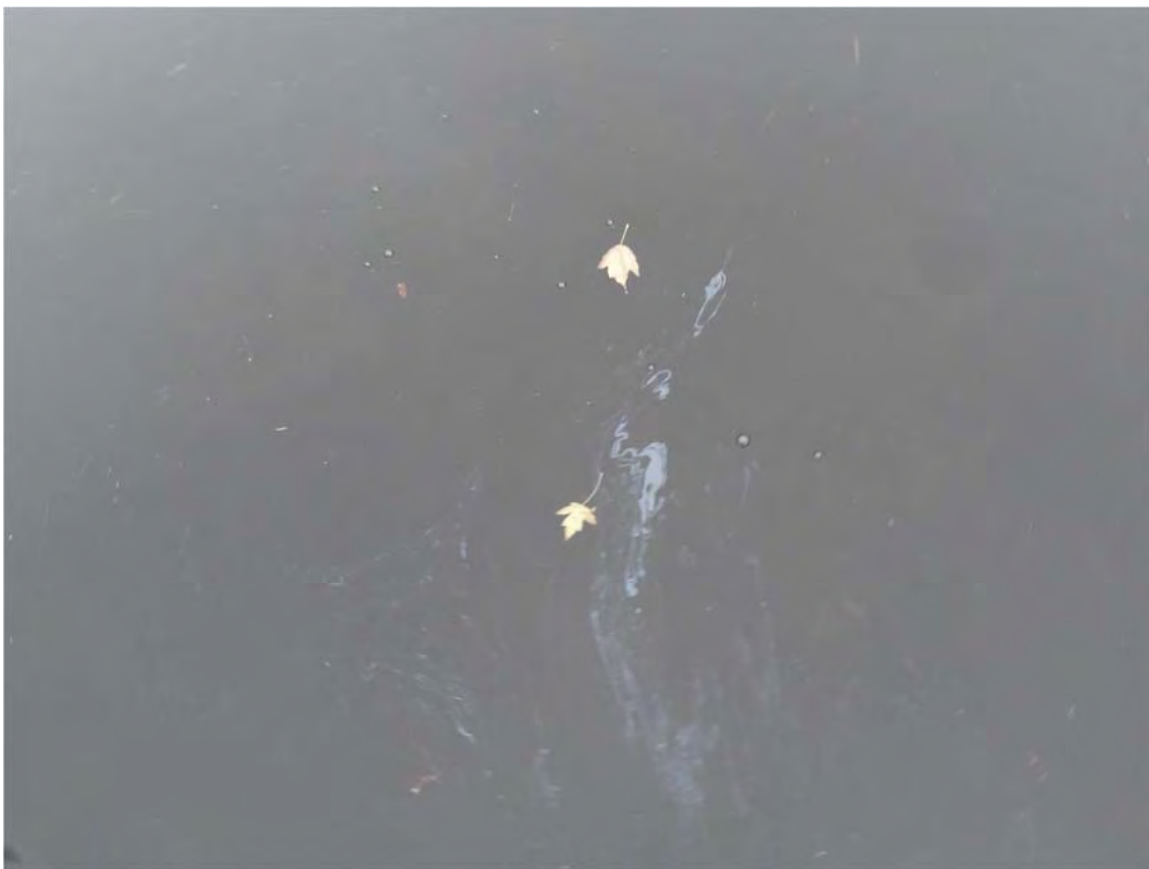
10. Ceresco Dam control point boom observed sheen collecting along the control point boom.

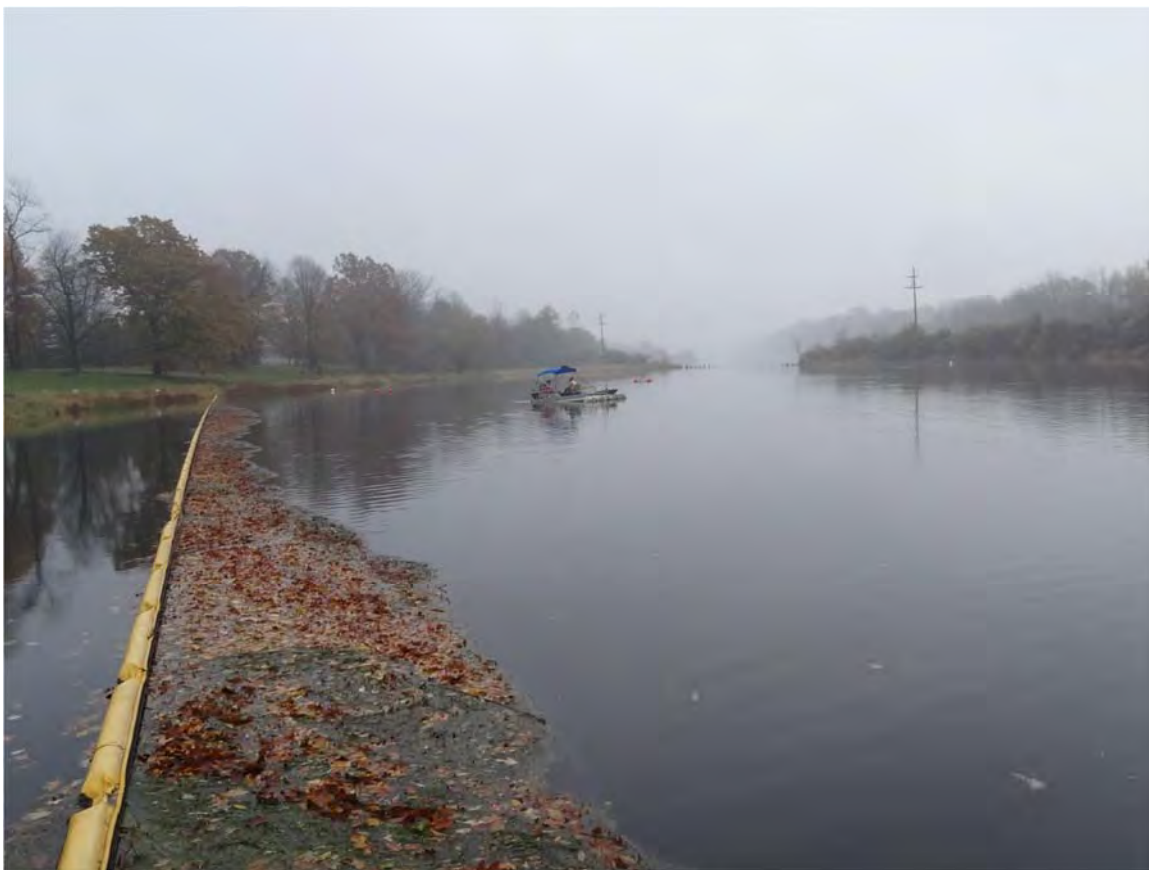
11. Ceresco Dam observed the sweep boat arriving to begin debris removal from the control point boom.

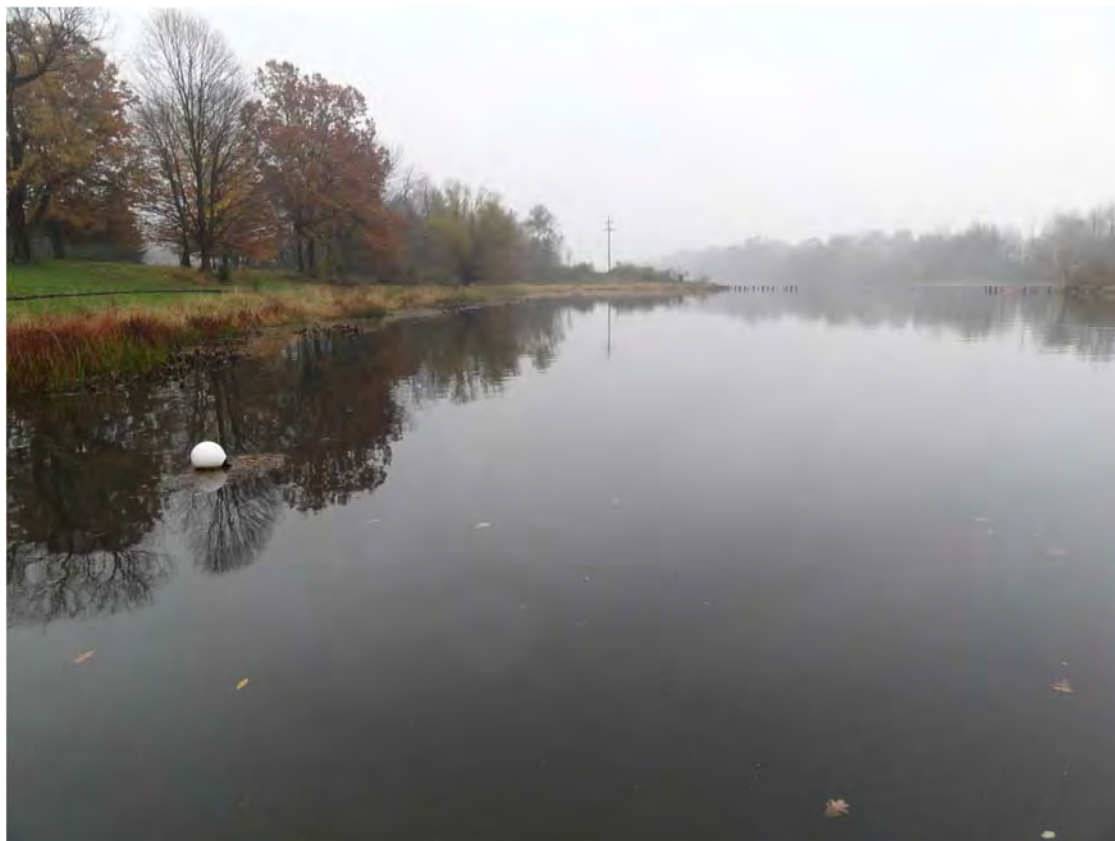
12. MP5.75 RDB area where sheen and tar globs were observed.

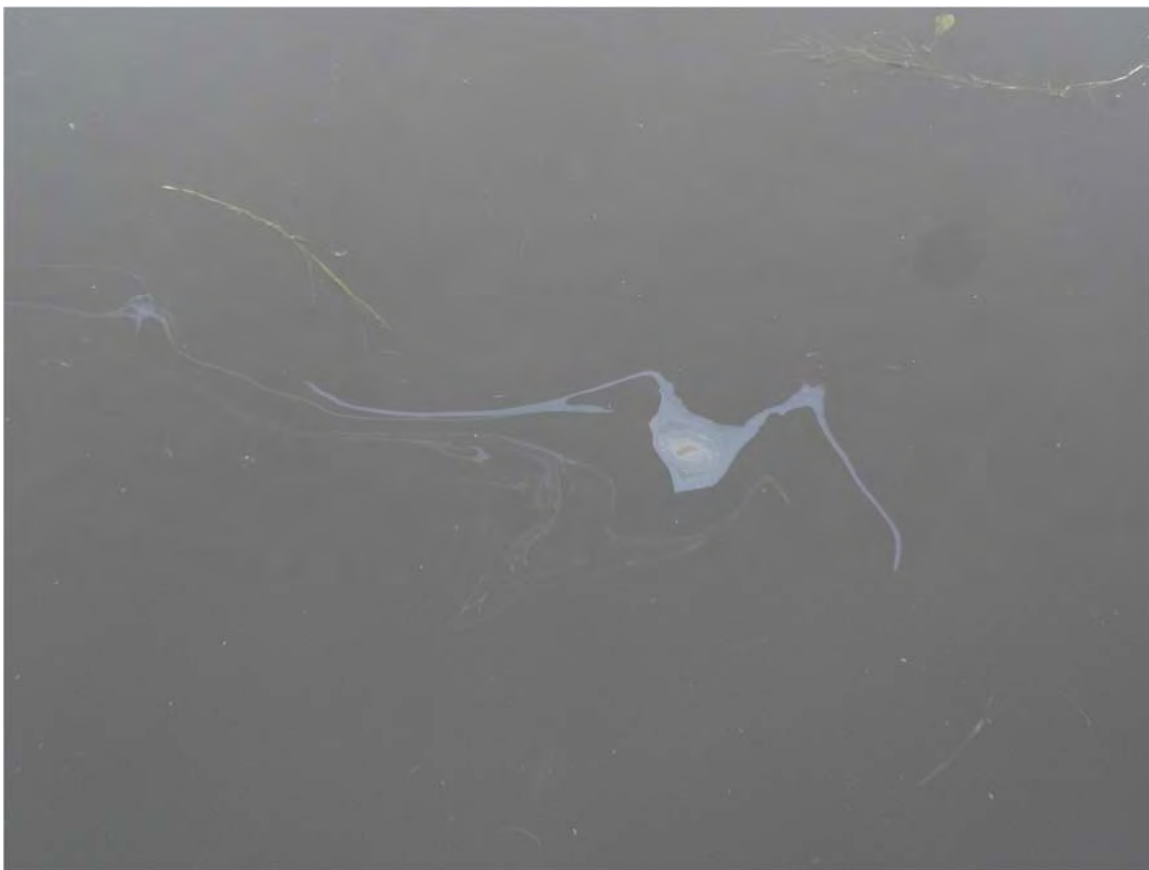
13. MP5.75 RDB sheen and tar globs observed.

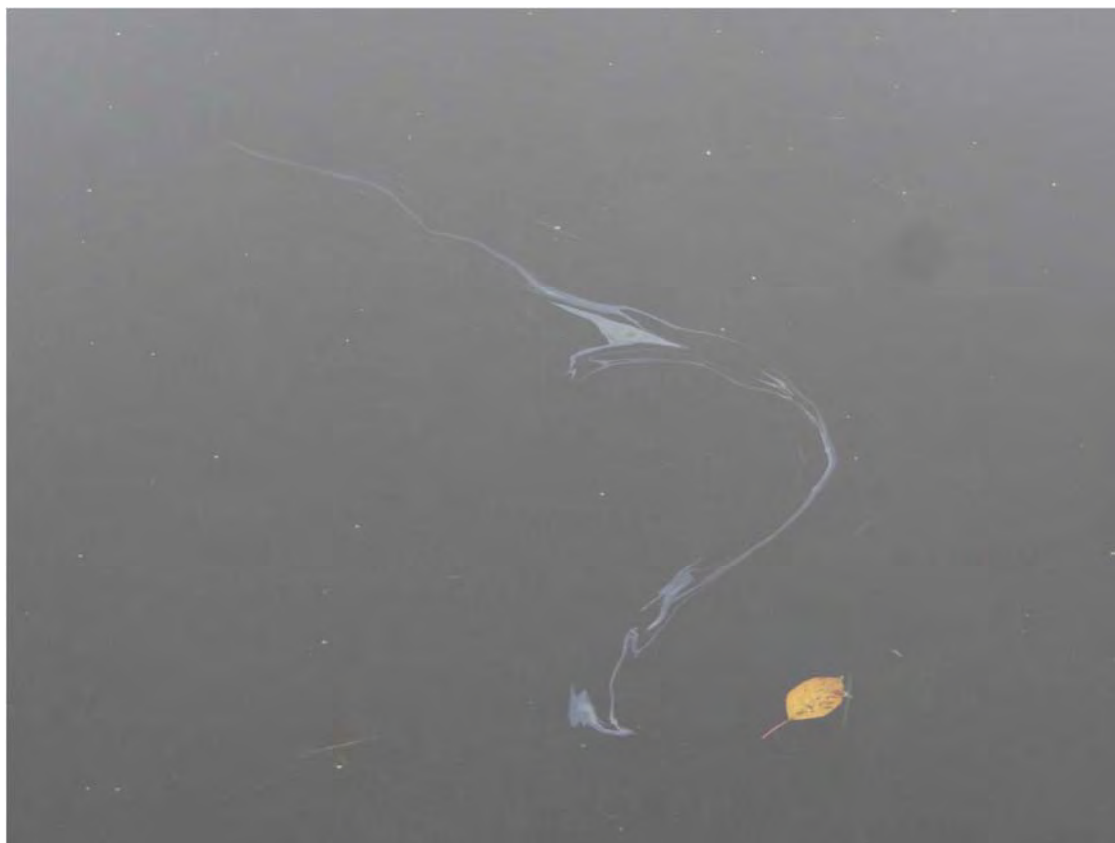
14. MP5.75 RDB sheen and tar globs observed.

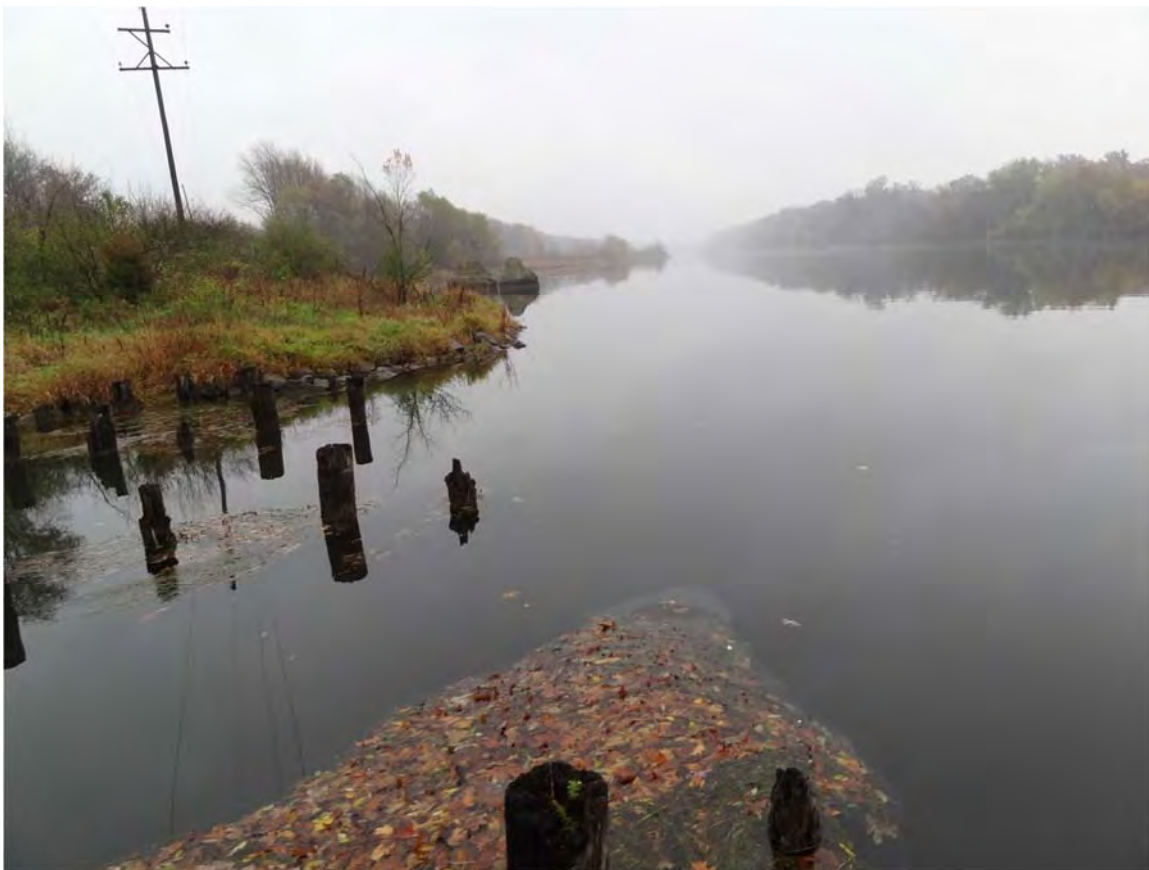
15. MP5.55 RDB area where sheen and tar globs were observed.

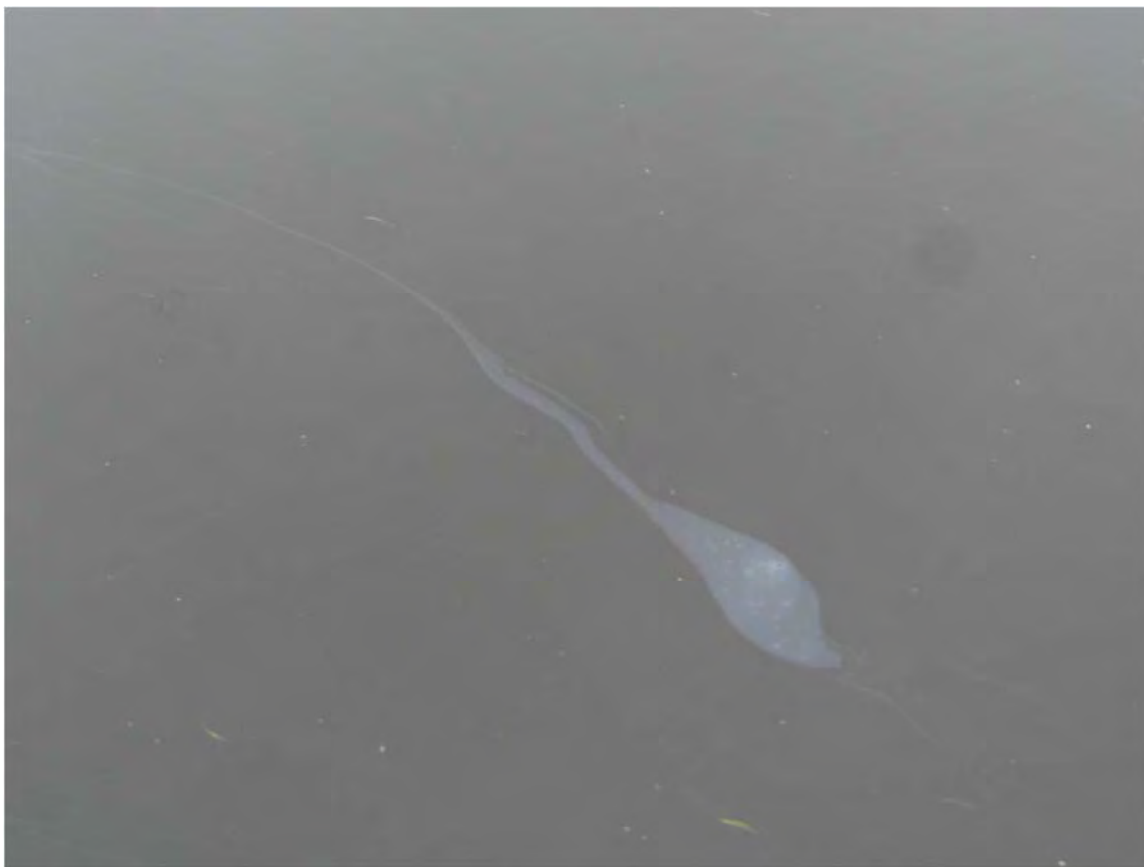
16. MP5.55 RDB sheen and tar globs observed.

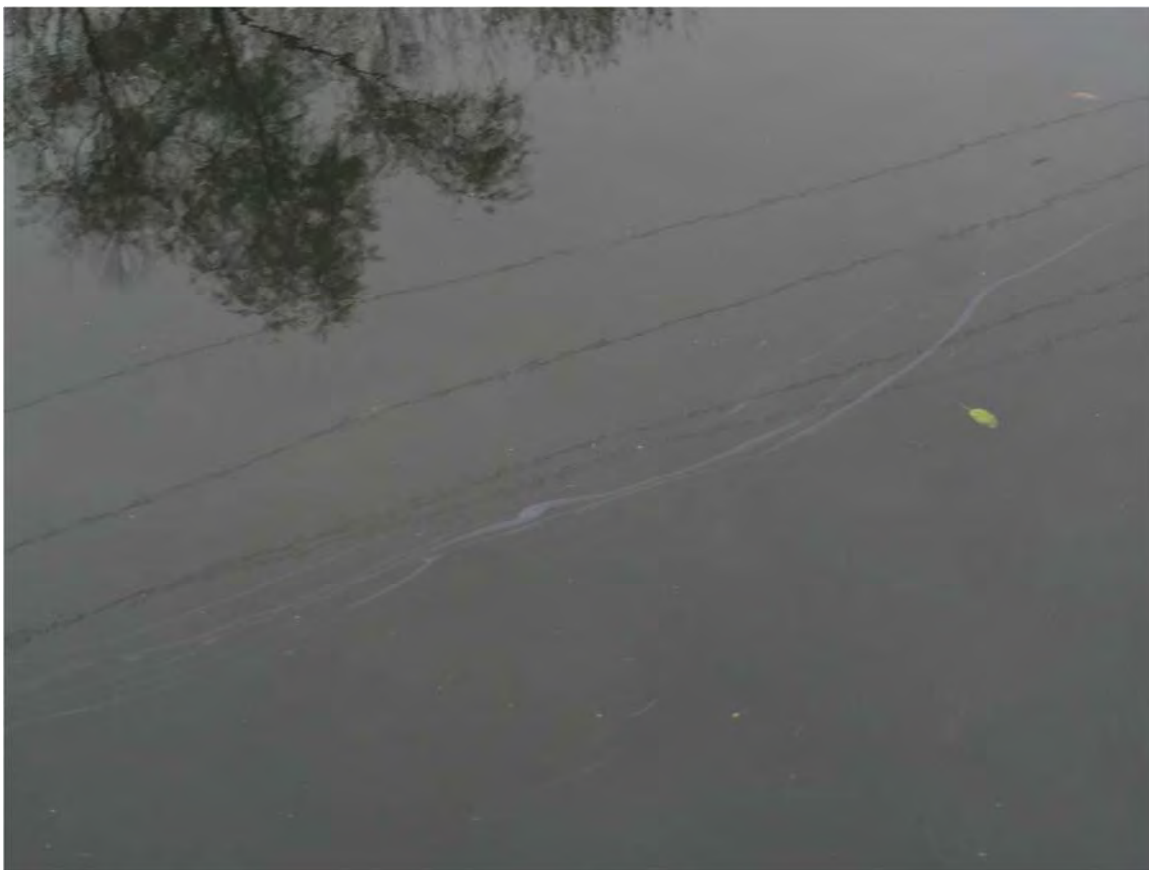
17. MP5.55 RDB sheen and tar globs observed.

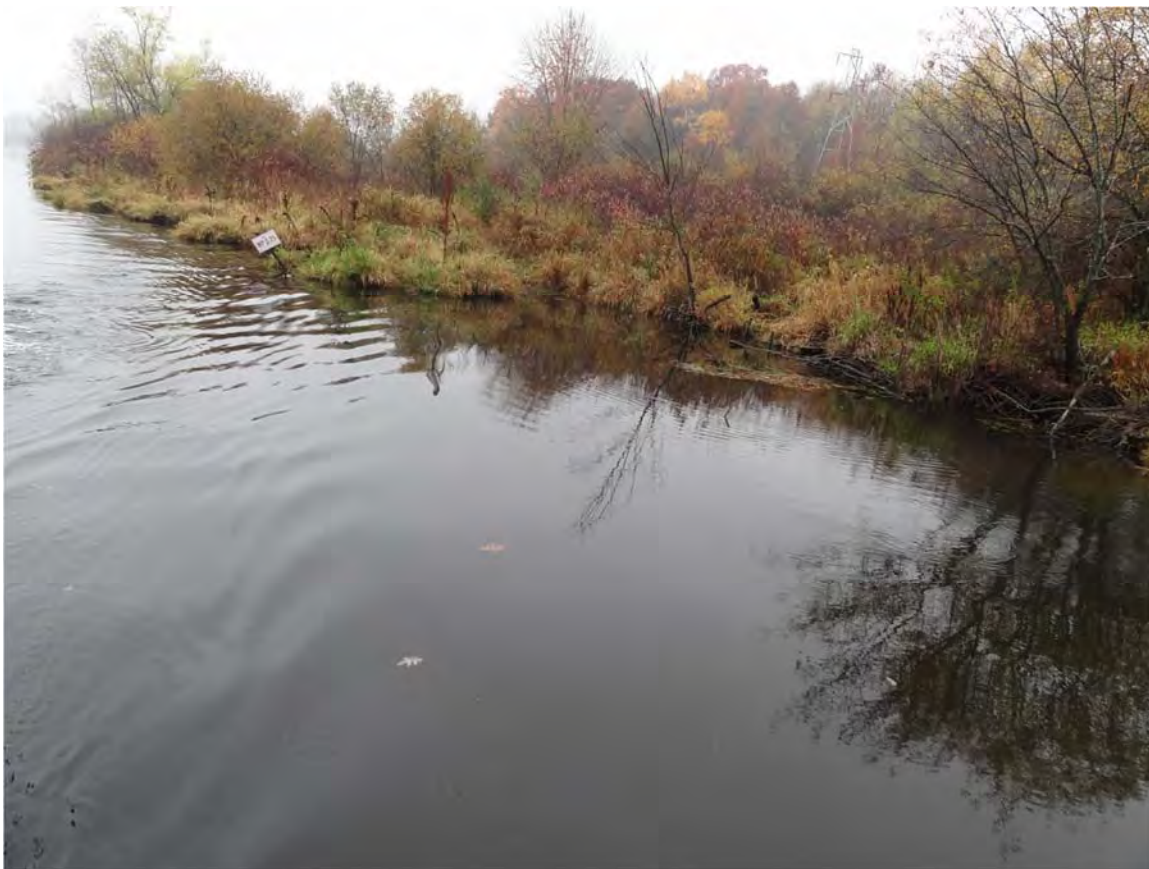
18. MP5.25 RDB area where sheen and tar globs were observed.

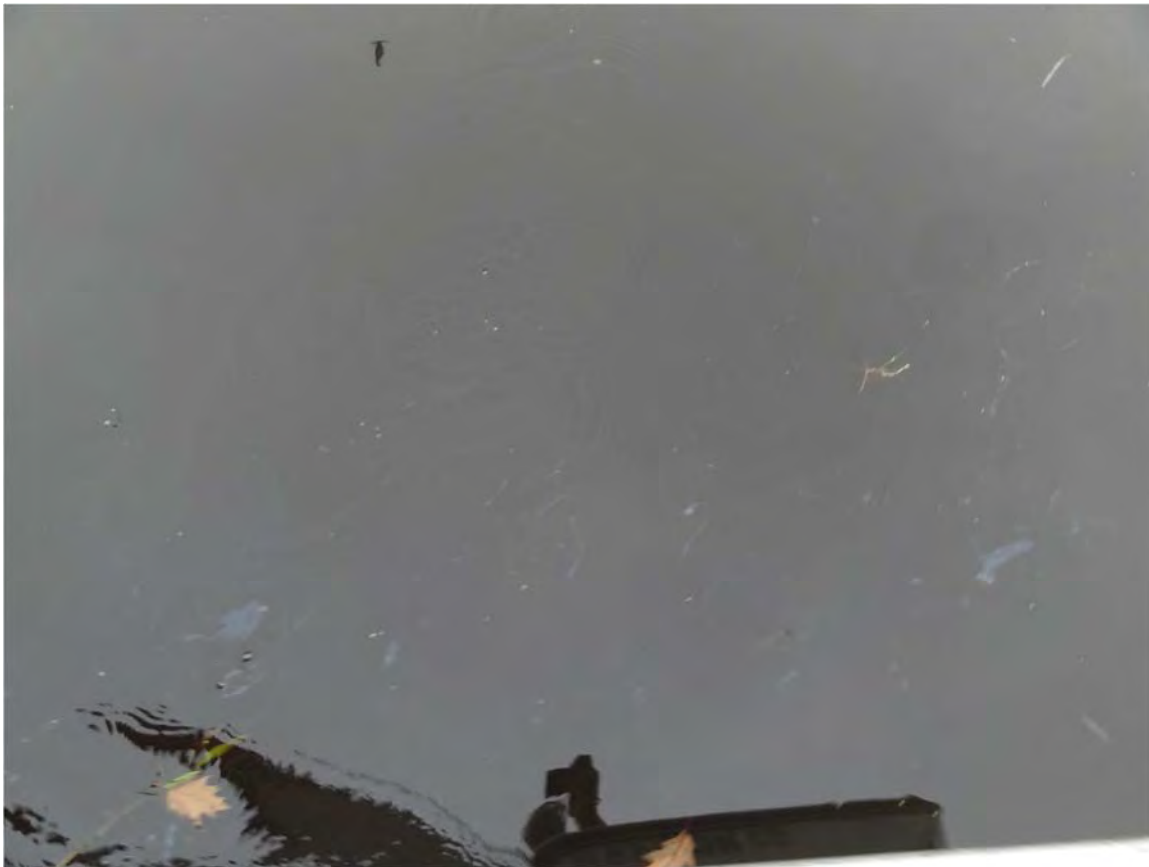
19. MP5.25 RDB sheen and tar globs observed.

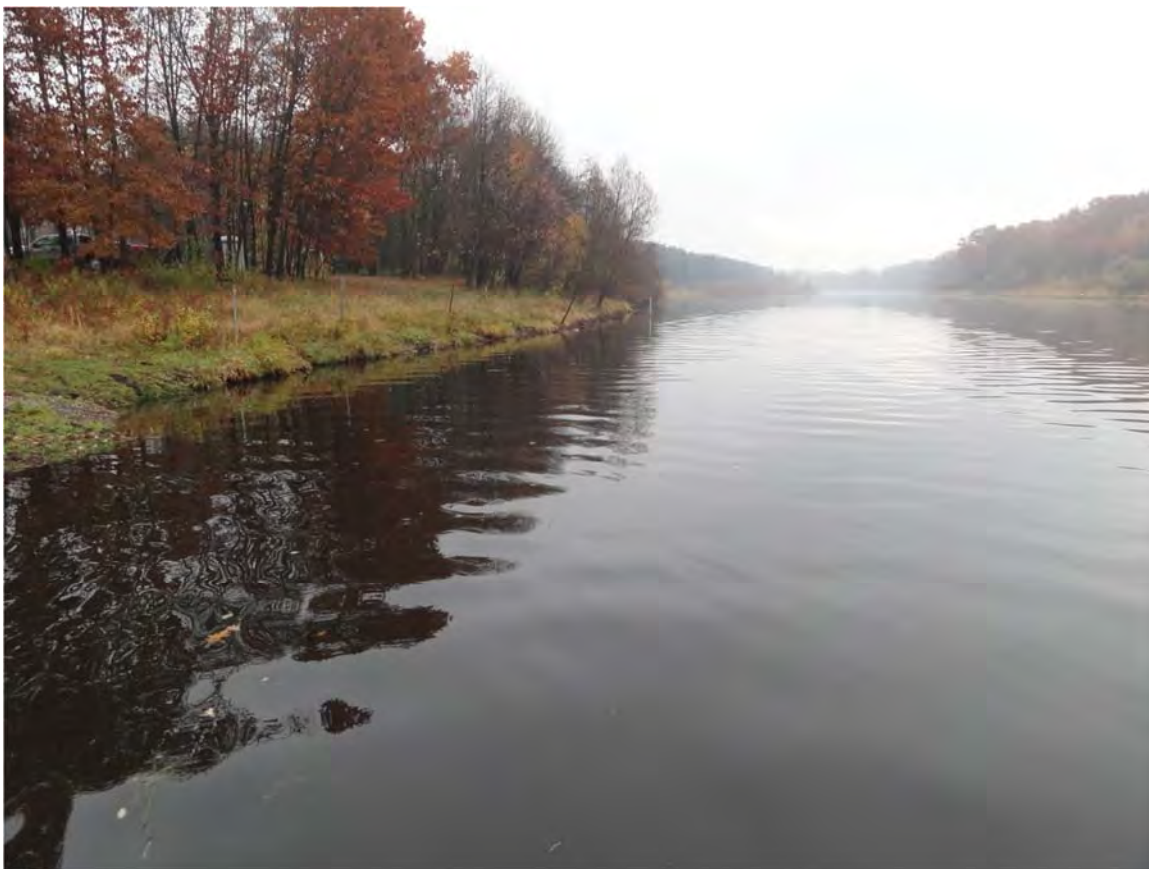
20. MP5.15 RDB area where sheen and tar globs were observed.

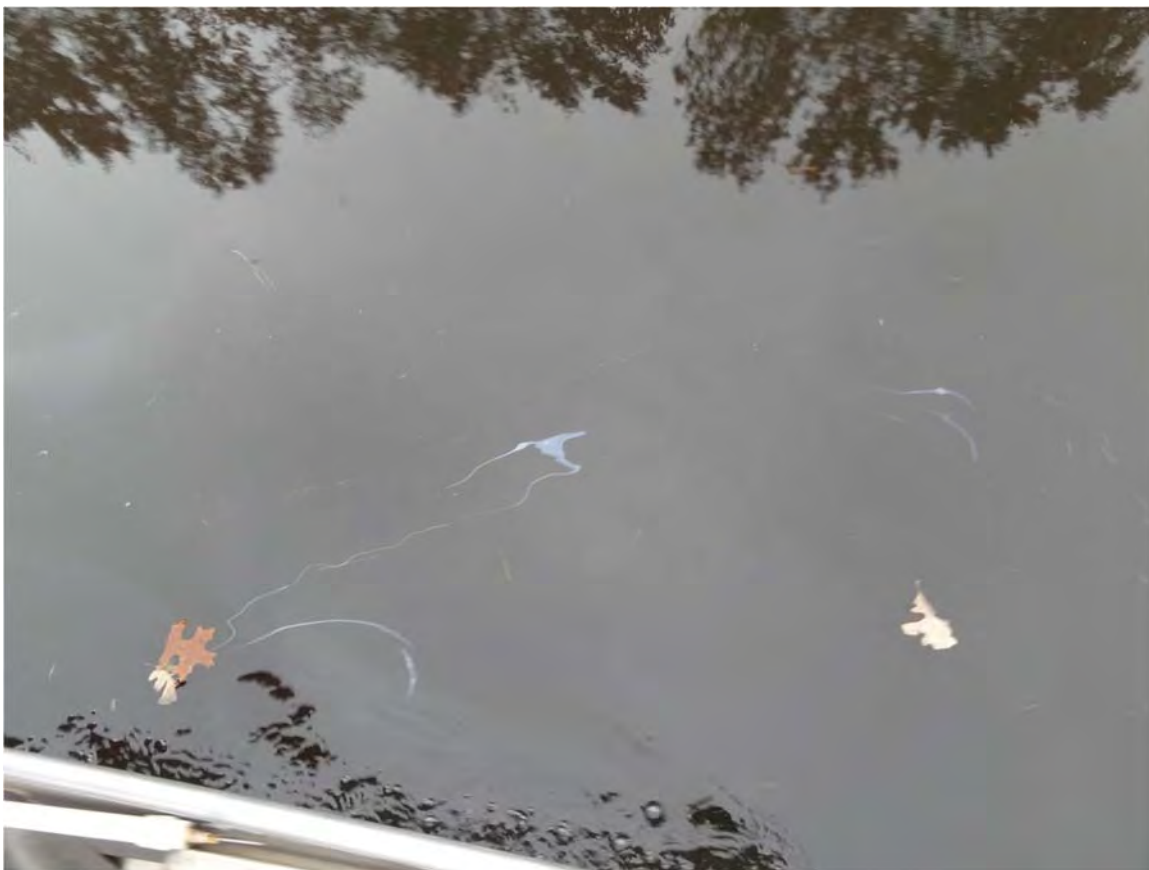
21. MP5.15 RDB sheen and tar globs observed.

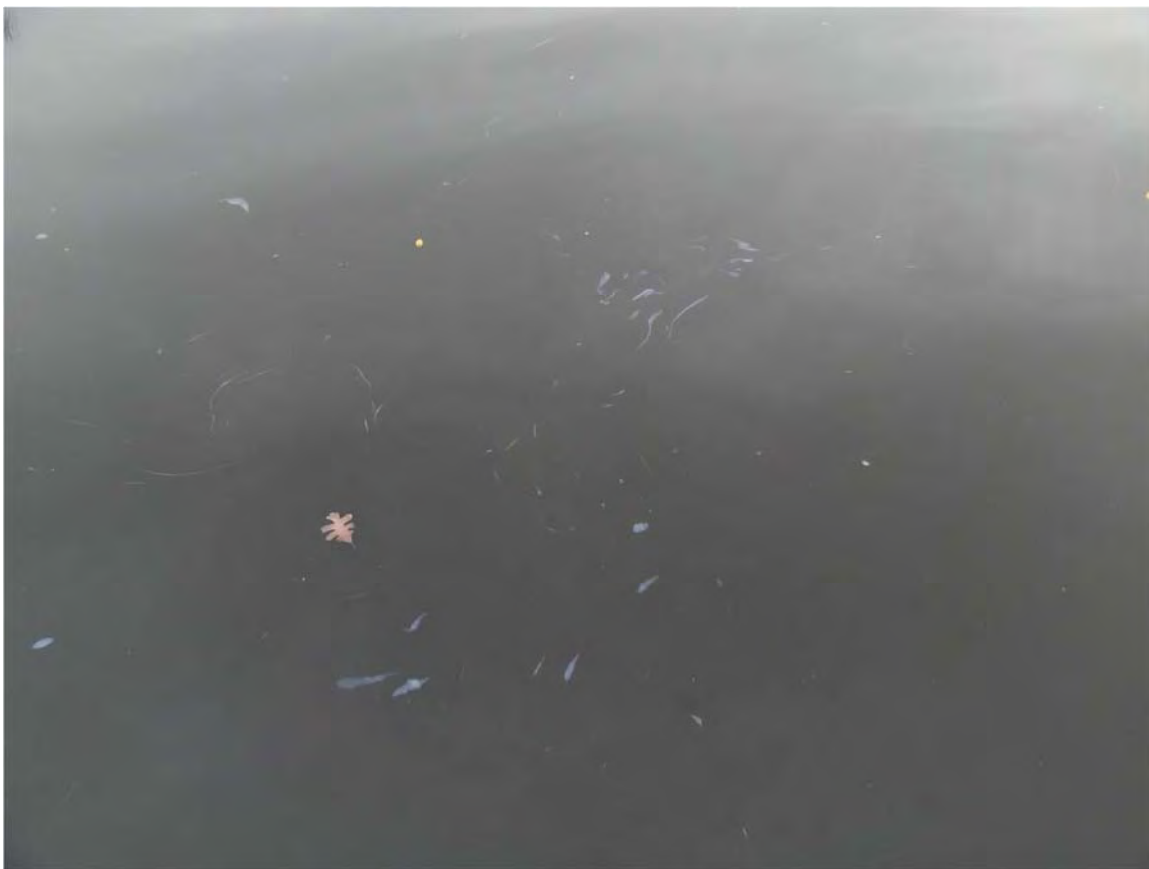
22. MP5.15 RDB sheen and tar globs observed.

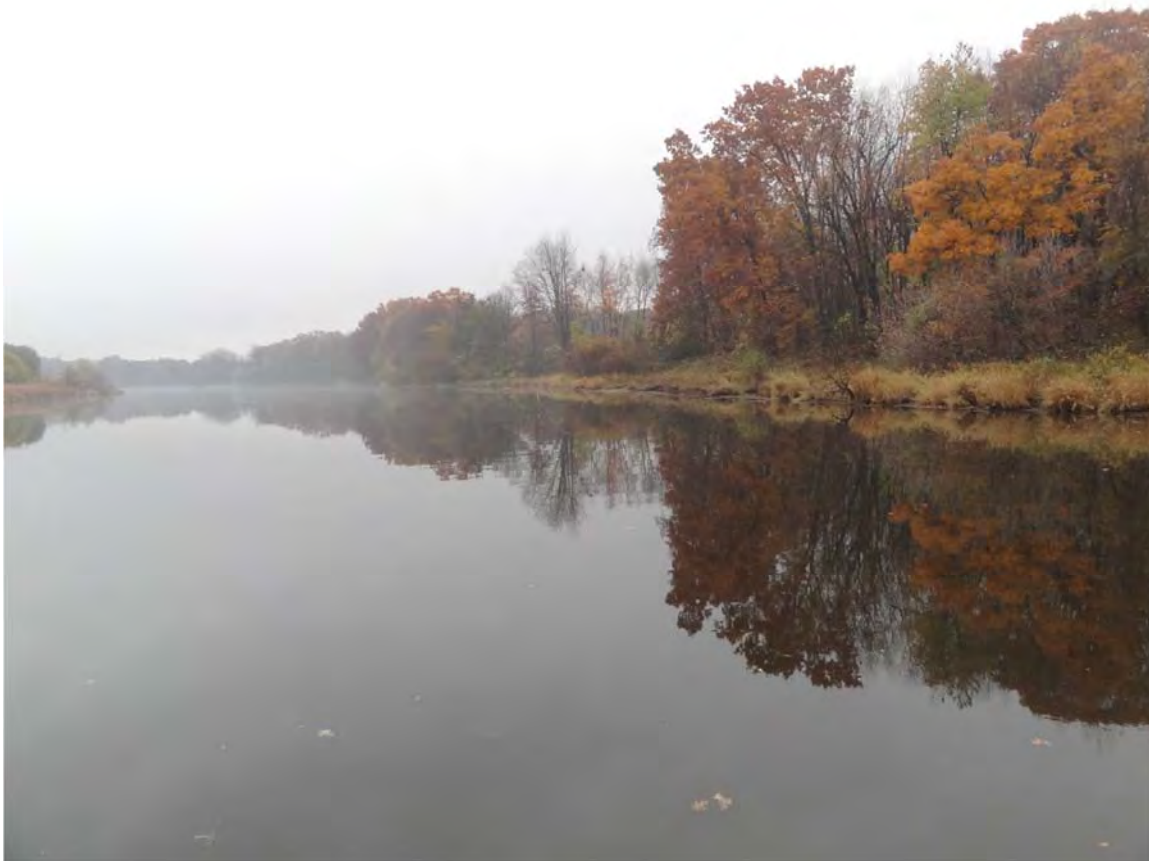
23. MP4.75 LDB area where sheen and tar globs were observed.
